# The Australasian Wind Engineer

### Technical Note - Kurnell Tornado and Thunderstorm Outflow Events: 16 December 2015

**Contributors: Richard J. Krupar III<sup>1</sup>, Matthew S. Mason<sup>1</sup>, Matthew J. Glanville<sup>2</sup>**

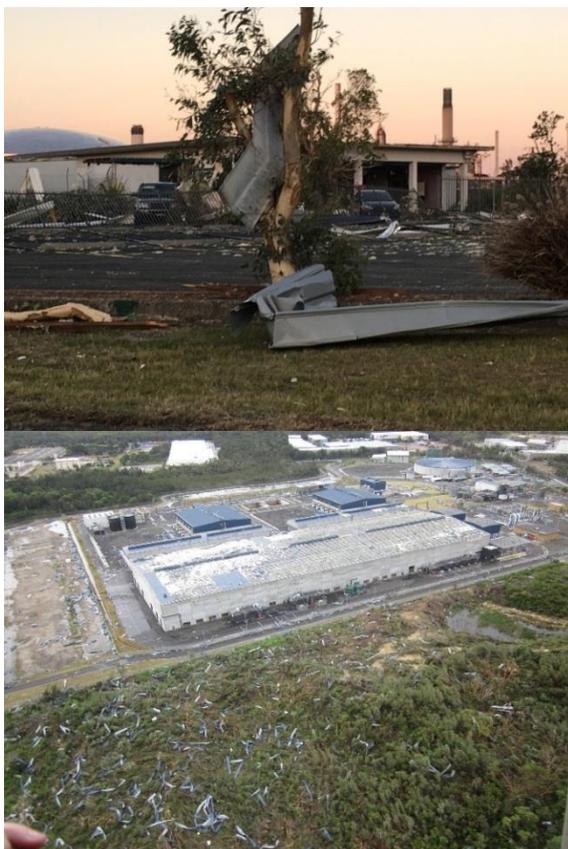
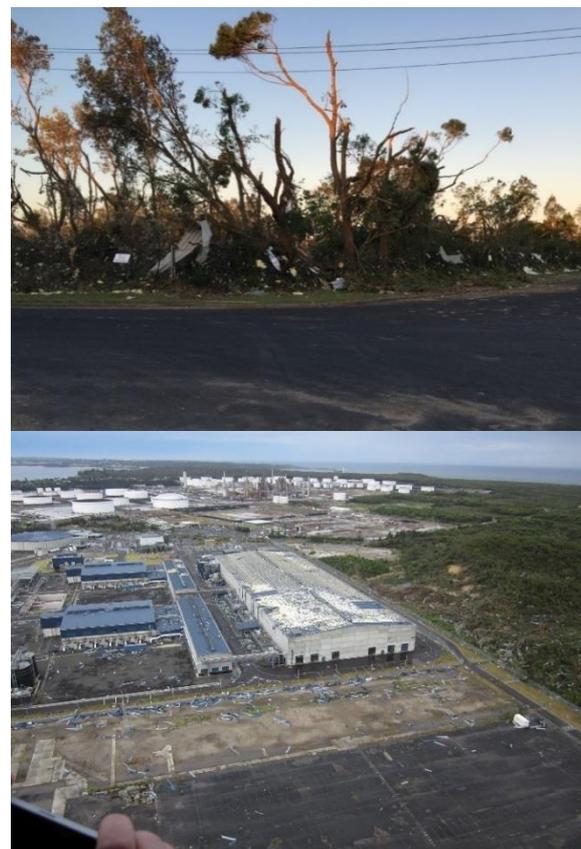
*Figure 4. Examples of the debris from the desalination plant and surrounding buildings. The upper two images are from Sir Joseph Banks Drive and the lower two images were captured by the Westpac Lifesaver Rescue Helicopter over the desalination plant.*

Continuing north, the desalination plant lost metal deck sheeting over much of its roof plan with sheeting and insulation found deposited hundreds of metres from the plant. Much of Sir Joseph Banks Drive was littered with debris from this and other buildings (Figure 4). Distinct signs of multidirectional flow can be seen in the lower two images of Figure 4, where roof sheeting is seen deposited on all sides of the plant building. A clear swathe of sheeting is shown to the south (lower left) of the plant—this is the opposite direction to the movement of the storm—with sheeting also seen to be blown hard-up against the southerly side of the fence in the lower right image. Industrial units in the direct path suffered façade breaches including broken windows and lifted roof sheeting. On Chisholm Road a lorry was blown over onto an adjacent and thankfully empty parked car (Figure 5). As the tornado continued northwards crossing Captain Cook Drive it passed over roadside high voltage transmission lines, but no damage was evident to these structures. Similarly, no obvious damage could be sighted to the refinery east of Captain Cook Drive.

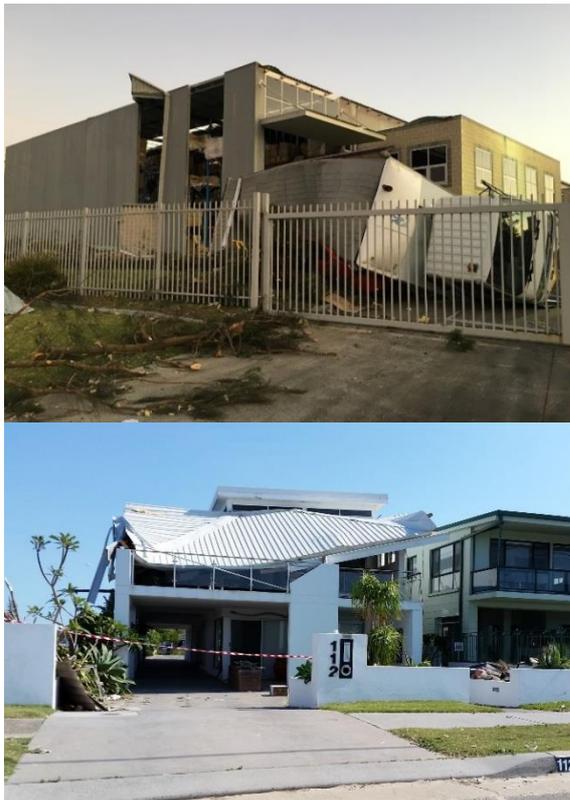
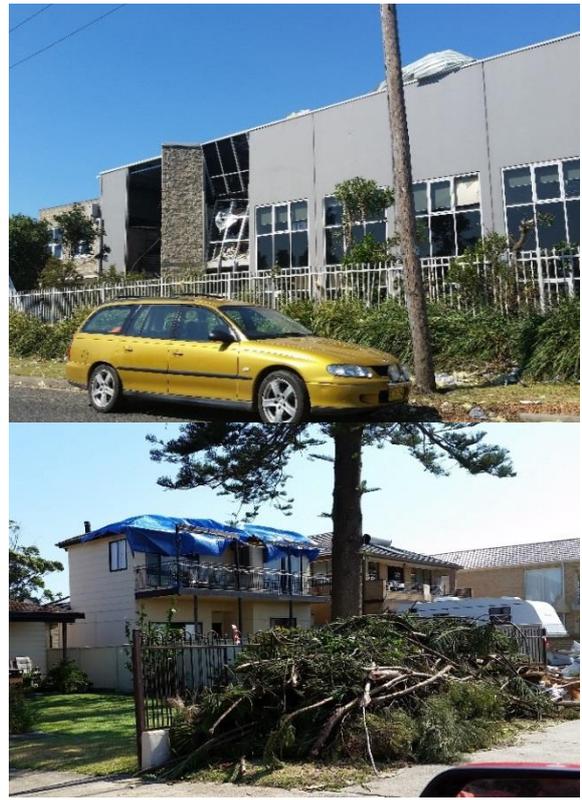
*Figure 5. Examples of damage to industrial buildings (upper two) and residential buildings (lower two).*

The tornado passed directly over the residential township of Kurnell northward to Botany Bay. Inspecting damage in the residential zone was reminiscent of surveying water spout damage in Lennox Head 2010 in that damage was confined to a finite width outside of which little permanent damage could be observed. (Figure 5). Roof damage was common to buildings in the damage swathe, with lifted roof sheeting, missing tiles and lifted solar panels observed. Temporary structures were also displaced (e.g. garden sheds, awnings a trampoline and fallen trees). An interesting video of the swathe captured by a drone flight (<http://www.dailymail.co.uk/news/article-3363439/Drone-footage-shows-damage-Kurnell-tornado.html>) shows the extent of damage through the township.
