## Tornadic Waterspout Impacts on Coastal Australia

M.J. Glanville<sup>1</sup>, C.J. Rohr<sup>1</sup> and J.D. Holmes<sup>1</sup>

<sup>1</sup>Cermak Peterka Petersen Pty Ltd,

### Abstract

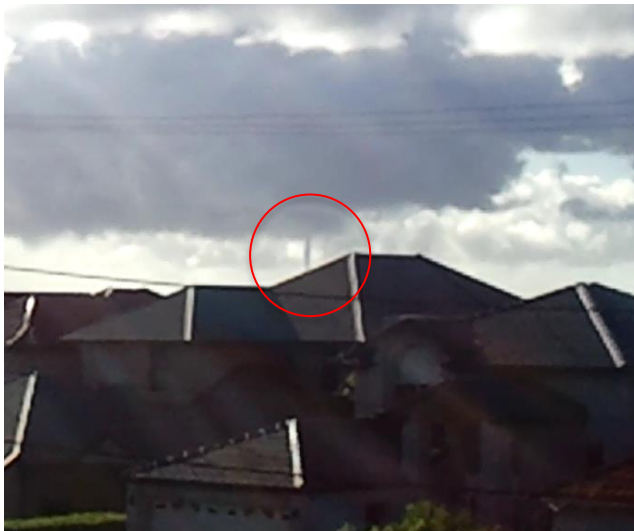
Figure 1: Fair weather waterspout sighted by first author off the coast of North Curl Curl, Sydney (2013).

### Introduction

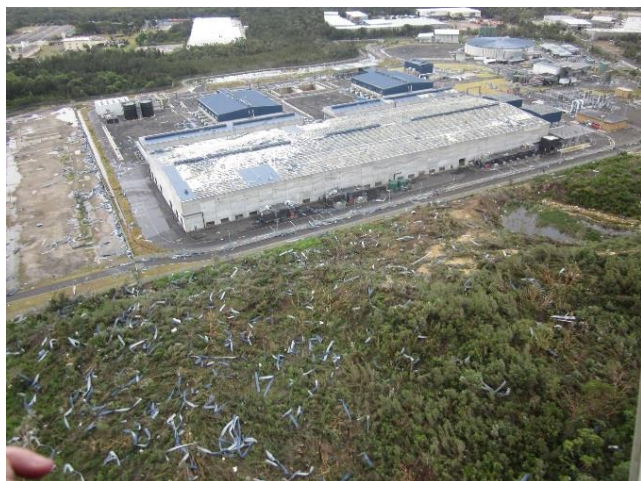
Continuing north, the desalination plant lost metal deck sheeting over much of its roof plan with roof sheeting and insulation found deposited hundreds of metres from the plant. Distinct signs of multidirectional flow can be observed in Figure 3, where roof sheeting from the desalination plant is seen deposited on all sides of the plant building. A clear swathe of sheeting is shown to the south (lower left) of the plant. This is the opposite direction to the movement of the storm.

Figure 3: Debris from the desalination plant and its surrounding buildings captured by the Westpac Lifesaver Rescue Helicopter.

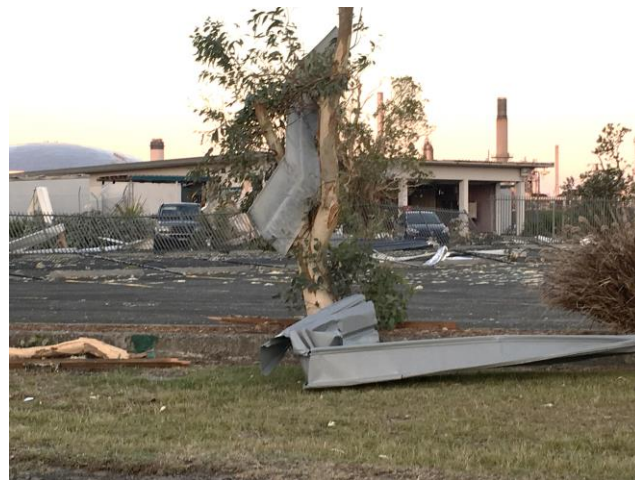
Much of Sir Joseph Banks Drive was littered with debris from this and other buildings (Figures 4).

Figure 4: Debris from the desalination plant and other surrounding buildings on Sir Joseph Banks Drive, Kurnell.

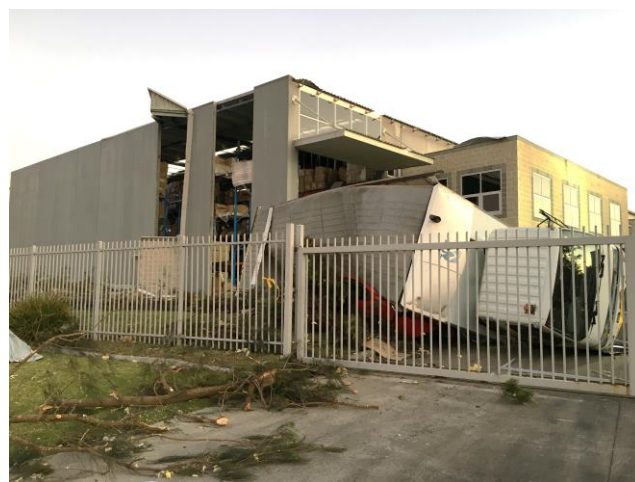
Industrial units in the direct path suffered façade breaches including broken windows and lifted roof sheeting. On Chisholm Road a lorry was blown over onto an adjacent and thankfully empty parked car (Figure 5). As the tornado continued northwards crossing Captain Cook Drive it passed over roadside high voltage transmission lines, but no damage was evident to these structures. Similarly, no obvious damage could be sighted to the refinery east of Captain Cook Drive.

Figure 5 Damage to industrial building on Chisholm Road, Kurnell, with overturned truck in foreground.

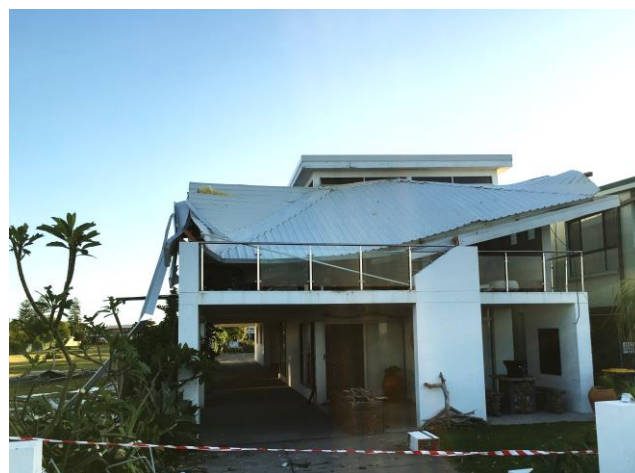
The tornado passed directly over the residential township of Kurnell northward to Botany Bay, Figure 6. Inspecting damage in the residential zone was reminiscent of surveying water spout damage in Lennox Head 2010, with damage confined to a finite width outside of which little permanent damage could be observed. Roof damage was common to homes in the damage swathe, with lifted roof sheeting, and missing tiles, and removed solar panels.

Figure 6: Damage to a residential home in the Kurnell township.

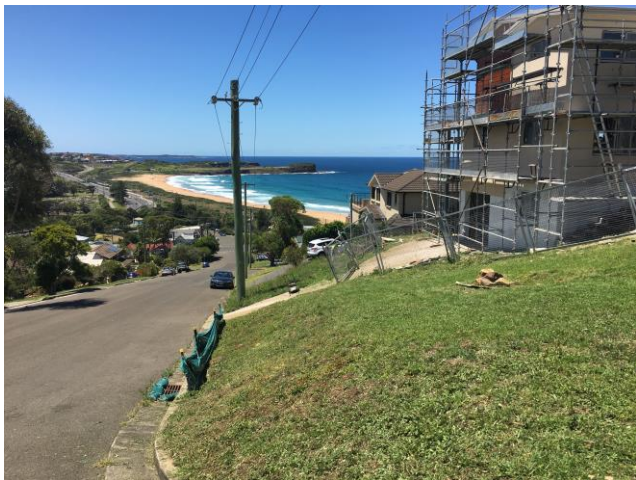
Property damage at Kiama was similar to that in the Kurnell and Lennox Head events, based on media reports and verbal discussions with Kiama residents by the first author. Figure 7 illustrates a home re-build still in construction almost three years after the event. The waterspout was reported to have come off the ocean causing damage to properties on the hill crest (camera location) before continuing south then inland toward Jamberoo.

Figure 7: Hothersal Street, Kiama photo taken January 2016.
